## International Journal of Geography, Geology and Environment

# Application of selected engineering geological methods for landslide hazard assessment in the Klisan/Sartka area, western Sulaymaniyah

**Abbas Abdulaziz Sharif and Aomed A Tocmachy**

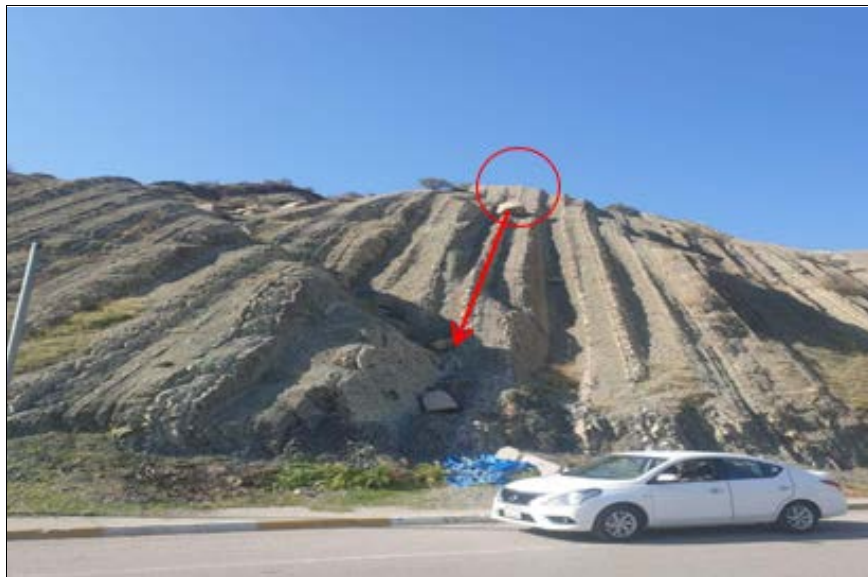
The results of the slope engineering assessment, as shown in the Table (4), indicate that it falls within the sixth category in terms of severity, "Very High," based on a total score of 27 points. Several geological and geomorphological factors have contributed to increasing the level of risk, the most notable of which are the steep slope exceeding 35 meters and the sharp inclination angle ranging between 45° and 60°, which increases the likelihood of landslides. The rocks

also showed a high degree of fracturing and weathering, in addition to very minimal spacing of the joints (less than 0.05 m) and an unfavorable orientation of these joints relative to the layer dip, which are critical factors in assessing slope stability. Additionally, the limited vegetation cover and the presence of seasonal surface water, along with previous landslides, enhance the high-risk classification. Accordingly, this site is considered one of the most dangerous locations, especially with the presence of tourist facilities and parking lots at the bottom of the slope, which necessitates urgent engineering interventions to mitigate potential risks

**Fig 4:** Station 4 on the slope showing the collapse of large rock masses down the slope due to weathering, erosion, and gravity.

After careful analysis of the dataset and field information measured, several distinct hazard categories emerged. Station ST.4 has a very high Landslide Probability Index (LPI) of 27, placing it in the "very high" hazard category. This scale indicates a high risk of landslides, necessitating immediate intervention, which may include slope reinforcement or a comprehensive soil assessment. Furthermore, due to the high Landslide Probability Indices (LPIs) at stations ST1 and ST2, which are 25 and 22, respectively, the two stations are classified as "high" hazards. Likewise, these sites pose a high risk and require close monitoring with proactive measures to maintain overall stability. In contrast, ST.2 has the lowest Landslide Probability Index (LPI) at 18, placing it in the "medium" risk category. At this stage, periodic monitoring should be sufficient for this site; however, cutting and filling

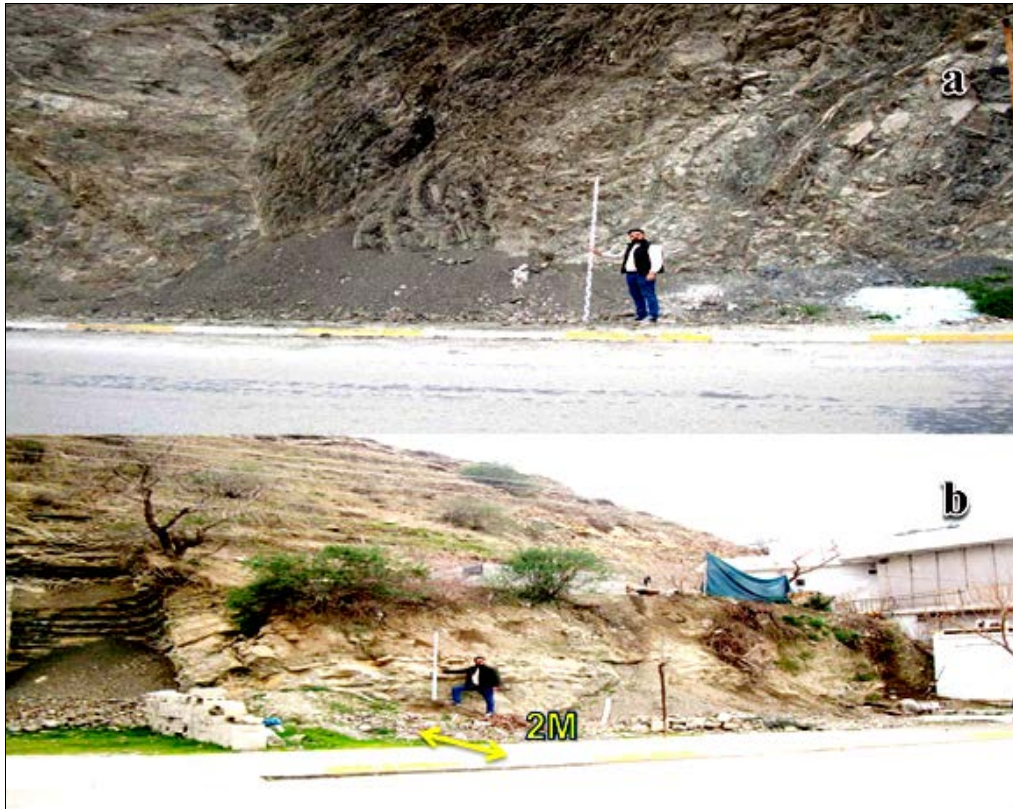
**Fig 5a:** Station No.2 The photo is taken in the direction of 072°, showing the slope face. However, the entire height of the slope could not be captured by the camera. **(Fig.5b)** It shows that the sidewalk is narrow, with a width of approximately 2 meters.

Station No. 2 is by far the most stable station, though, with the lowest L.P.I. rating of 18. The slope's overall stability is increased by its softer slope and less worn and weathered bedrock, which allow for adequate plant and water infiltration seasonally as shown in FIG (5a, 5b). In conclusion, the likelihood of landslides increases when several unfavorable elements are present, including slope height, slope angle degree, degree of fracture, a lack of vegetation, and previous landslides. Human actions can also increase this danger, such as clearing vegetation and changing natural drainage patterns. Protective actions, including replanting vegetation, enhancing drainage, and fortifying slopes, should be taken into consideration in order to lessen the likelihood of future landslides in regions like ST.1 and ST.4.
