## Rockfall hazard evaluation in Sargalu village: North of Iraq

**Hawraz Abdulqader Hasan and Aomed Ahmed Mohammed**

### Abstract

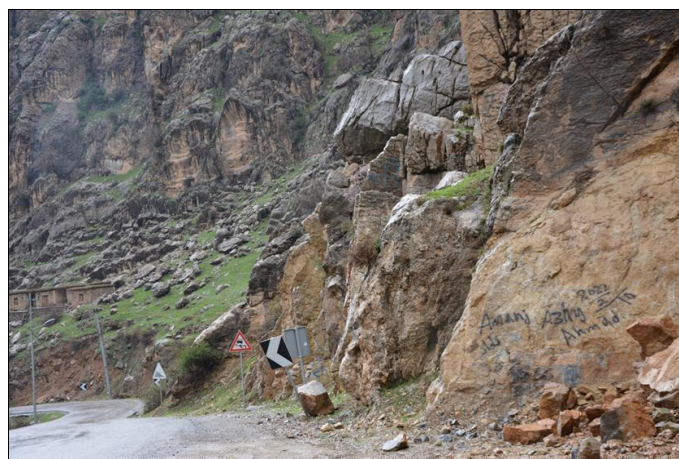
assigning appropriate values (points) to each slope or group of slopes. The length of the road is 88 meters. is located on the northeast wing of the Sardash anticline within Sargalu village, This study area is characterized by its narrow paved road and the absence of a ditch, as depicted in Fig.3. The line of sight visibility is relatively low fig.3. One of the main hazards in the area is the congestion of vehicles and tourists during the tourist seasons, as illustrated in fig.4. Additionally, the geological conditions play a prominent role in the study area due to the large rock blocks exposed to potential collapse. The values of the Rockfall Hazard Rating System (RHRS) coefficients in the study area are summarized in Table 1.

**Fig 2:** Shows an overall view of the slopes, the width of the paved road, and the absence of a ditch for rockfall

Thus, the slopes in the study area were classified as level two risk according to Table (2) in the risk assessment levels classification, which indicates a moderate level of risk. In such cases, warning signs, speed limits, daily road patrols, and some treatments to avoid the effects of landslides are required. Additionally, it is recommended to conduct detailed studies for the slopes along the road.

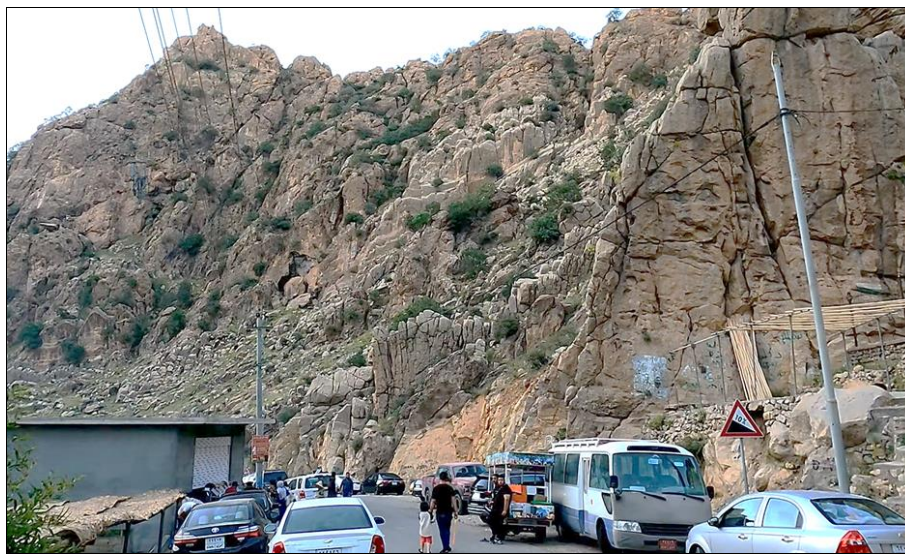
**Fig 4:** The risk of rock masses exposed to collapse on the road.

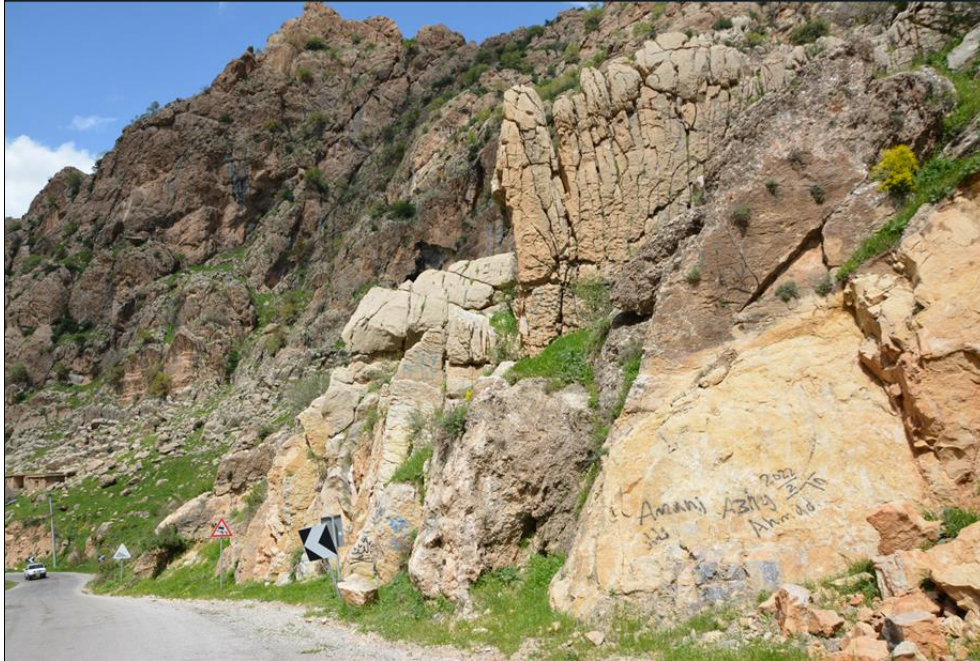
showed that the area is a high risk of rockfalls. The slope face in the study area has a length of 88 meters, facing 305 degrees, and has a slope angle ranging from 70 to 90 degrees. The exposed formation in the slope face is the Qamchuqa Formation, consisting of large dolomite rocks with layer thickness ranging from 1 to 1.5 meters, as shown in Fig.5. This is due to the significant spacing between joints, as illustrated in Fig.6. The rock layers are intersected along with three sets of discontinuities with dip and dip direction of 80/308 in the first set, 30/126 in the second set,

**Fig 5:** Shows the large dolomite masses in province.

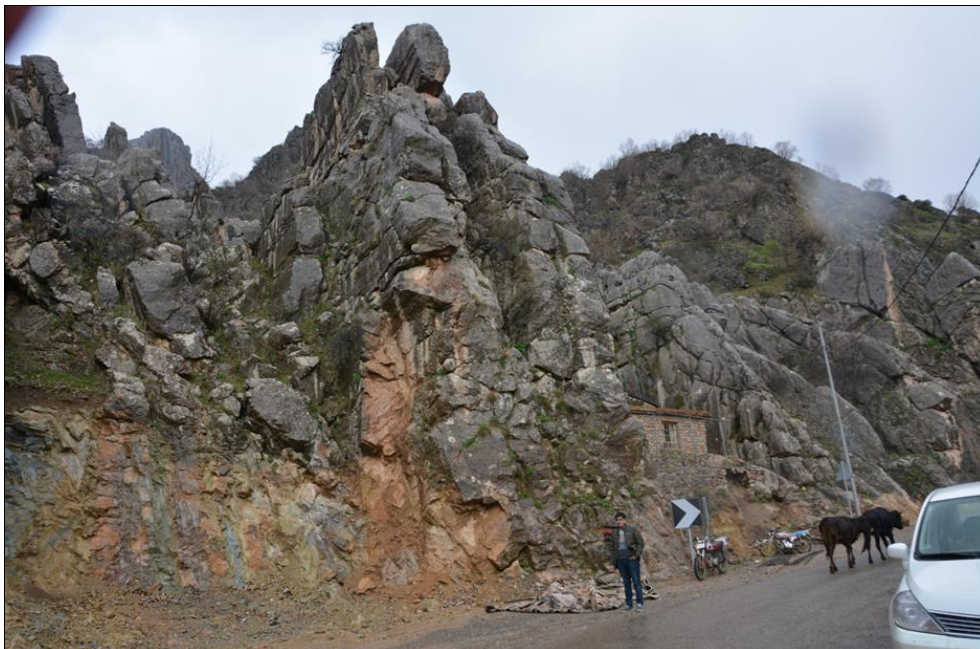
**Fig 6:** Presents an overall view of parts of the slopes and interspaces in the study area.

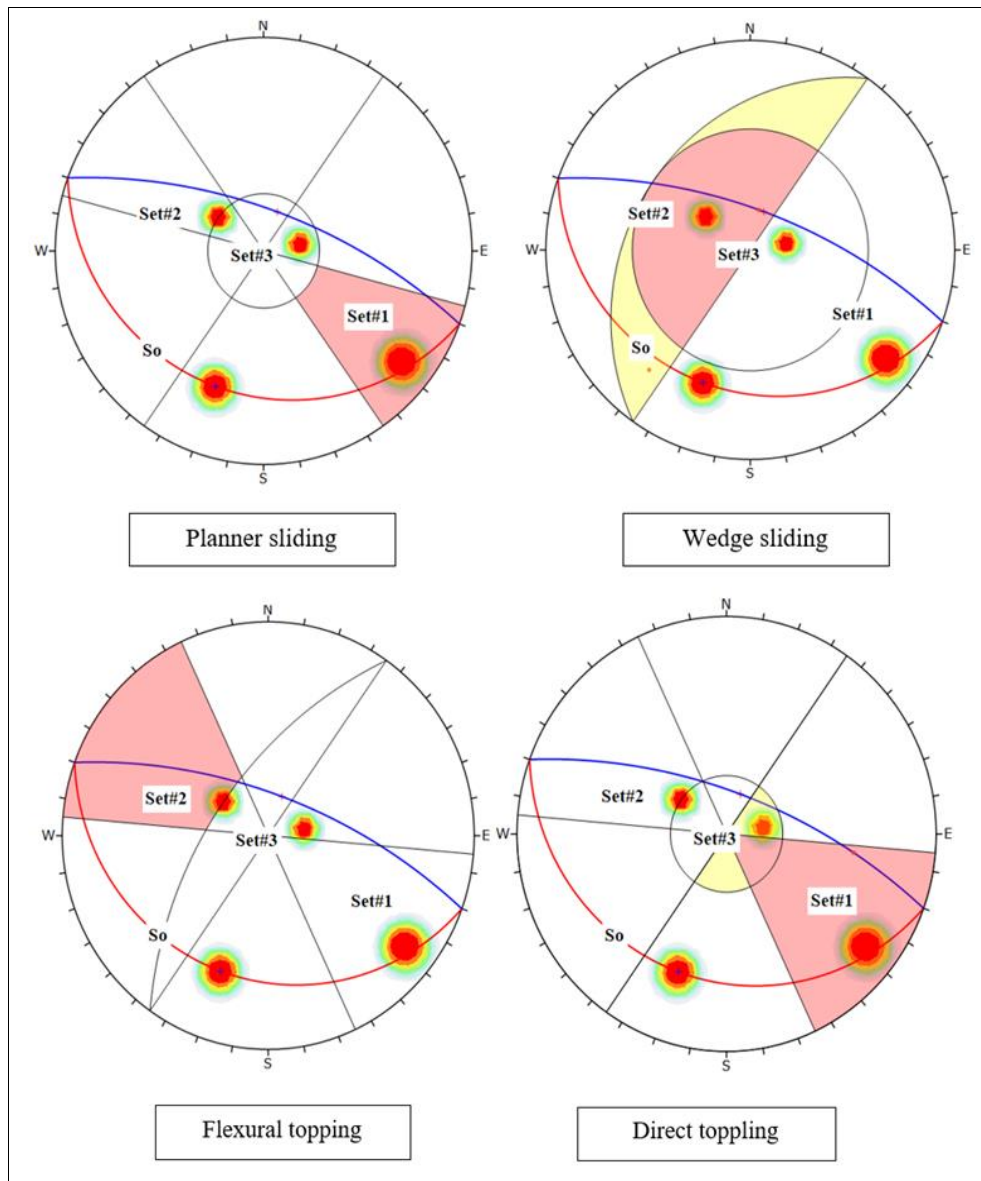
and 20/260 in the third set. Kinematic analysis indicated that the slopes are prone to various types of rockfall events, as depicted in the stereographic representation in Fig.7.

1. **Planner sliding:** The occurrence of the pole of discontinuity Set#1 in the collapse area indicates the possibility of this type of collapse.
2. **Wedge sliding:** There is a possibility of wedge sliding in this region due to the intersection of the discontinuity

levels Set#2 within the area of collapse.

3. **Flexural topping:** Flexural topping is likely to occur because there is intersections of discontinuity levels Set#2 within the area of influence for this type of toppling.
4. **Direct toppling:** This type of toppling is possible because the first Set#1 of discontinuity levels occurs within the area of influence for direct toppling.

**Fig 7:** three-dimensional projection diagram of the study area

5. Regarding the desk study using the Dips software, potential collapses in the study area include planar sliding, wedge sliding, and flexural topping and direct topping.
