## Disaster events and management in the Himalayan Watershed Gori Ganga, Kumaun Himalaya

### Abstract

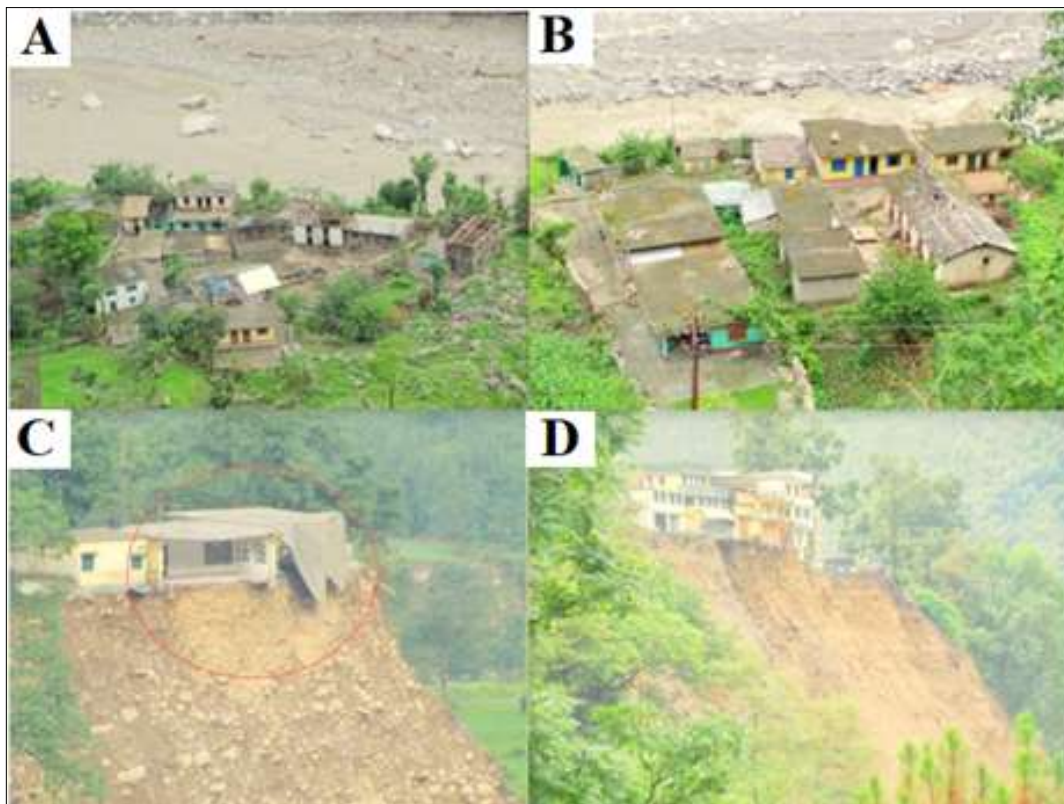
**Plate 1:** Damaged houses in Gori Ganga watershed: (A) at Umargada village in 2019, (B) at Balibagar village in 2019, (C) school building at Madkote village in 2013 and (D) at Madkote village in 2013.

The Gori Ganga watershed is constructed of two physiographic regions (Great Himalayan region and Lesser Himalayan region) which is divided by Main Central Thrust (MCT). This is the cause can provide more disaster sensitivity to the study area. In the present study Figure-2 depicts the distribution of sites of highly active natural disasters in the study area which is registered in Table-1. Plate-1 and Plate-2 presented example of disaster events in

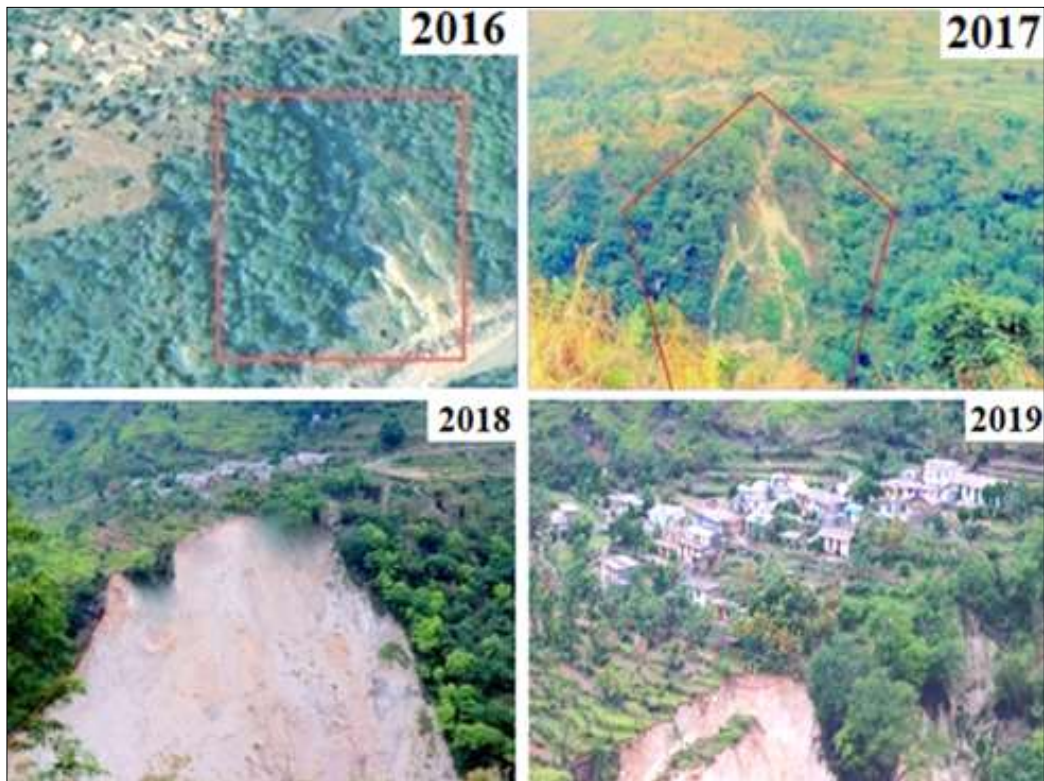
**Plate 2:** Heavy mass wasting at the village Tanga in 2016, 2017, 2018 and 2019 in the Gori Ganga watershed.

Disaster events are in mountain regions triggered by both natural and anthropogenic disturbances that initiate slope failure. Heavy rainfall, flash flood, landslides mass wasting, land creeping are the most devastating and recurring natural disasters and have deep adverse impacts in the study area. Figure-2 depicts the geographical distribution of 15 natural disaster sites of the last 6 years when occurs from 2006 to 2019 in the Gori Ganga watershed. The details of these disaster events are registered in Table-1. Due to these disaster events, the roads, bridges, houses sometimes entire the villages and hydro projects are damaged. Example of houses damaged by Gori Ganga and its tributaries during disaster events are presented in Plate-1 which shows (A) at Umargada village by Gori Ganga River in 2019, (B) at Balibagar village by Bona Gad in 2019, (C) Primary school building at Madkote town by Gori Ganga River in 2013 and (D) at Madkote town by Gori Ganga River in 2013. Example of hydro power project damaged by Gori Ganga and its tributaries during disaster events are presented in Example of heavy mass wasting by Bona Gad during disaster events in 2016, 2017, 2018 and 2019 at the village Tanga presented in Plate-2.

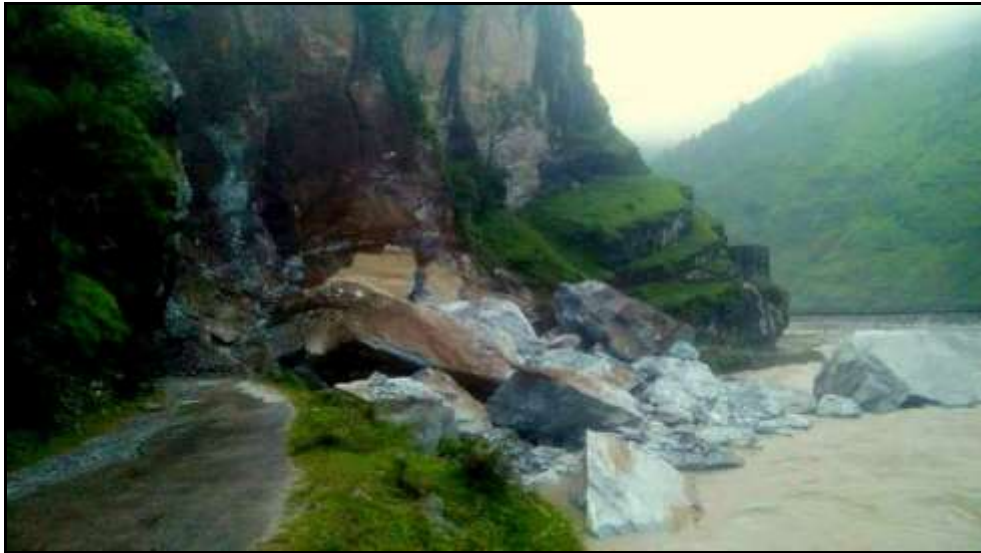
**Plate 3:** Huge rock fall caused by 2017 earthquake event at Kokila Mandir (Near Fagua) in the Gori Ganga watershed.

by each year having between 3 to 5 magnitudes. Earthquake of 5 to 6 magnitudes occurs after each 2 years while earthquake of magnitude above 6 occurs once in 10 years (Table 3) and Plate 3 shows the rock fall site at Kokila Mandir caused by the 18-11-2017 earthquake event in the Gori Ganga watershed having a magnitude of 3.3 between Nachani-Banshbagar.
